Manhole Inspection Summary

Manhole # S33E__027MH

Insp Date: **8/4/08 11:55 AM**

Location Address: **116 n liberty st**

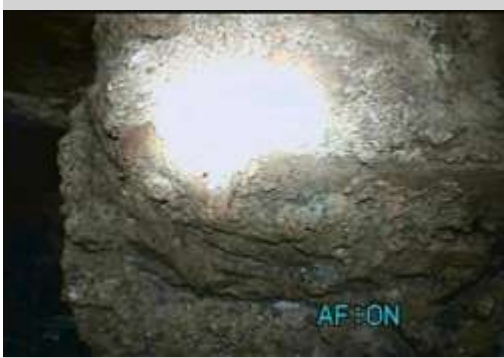
Defect 3

Condition: ☐ Sound ☐ Cracked ☐ Root Intrusion ☐ Deteriorated ☐ Leaks ☒ **Debris**

bench debris

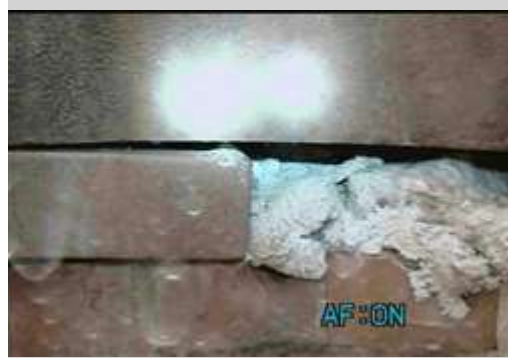
Defect 2

Condition: ☐ Sound ☐ Cracked ☐ Root Intrusion ☒ **Loose Brick** ☒ **Deteriorated**

loose bricks, deteriorated

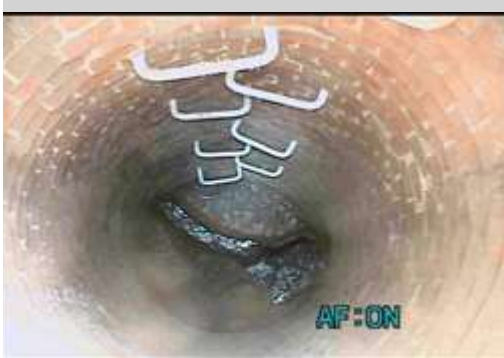
Defect 1

Count: **9** Missing: **0** ☒ **Corroded**

steps

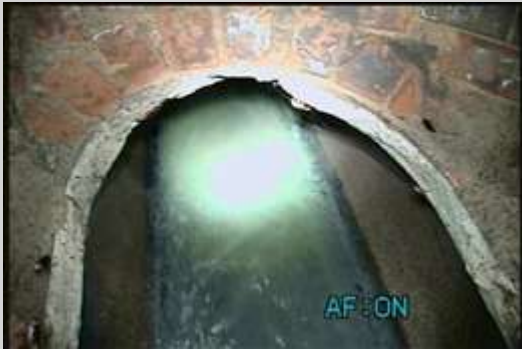
12 O'Clock Outflow

18 in. Circular Gravity Sewer
Pipe Out @ 12 O'Clock

Invert Depth: **15.92** (ft.) Flow Characteristics: **Fast**

Infiltration: **None** Pipe Seal Cond: **Unknown**

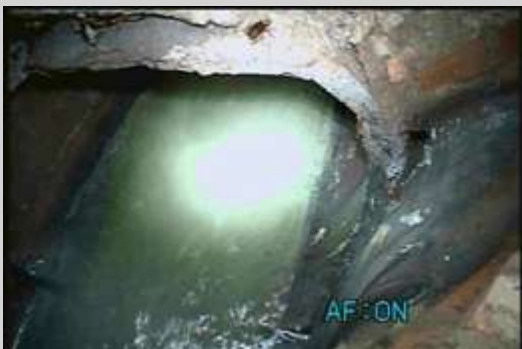
6 O'Clock Inflow

18 in. Circular Gravity Sewer
Pipe In @ 6 O'Clock

Invert Depth: **15.80** (ft.) Flow Characteristics: **Fast**

Infiltration: **None** Pipe Seal Cond: **Unknown**

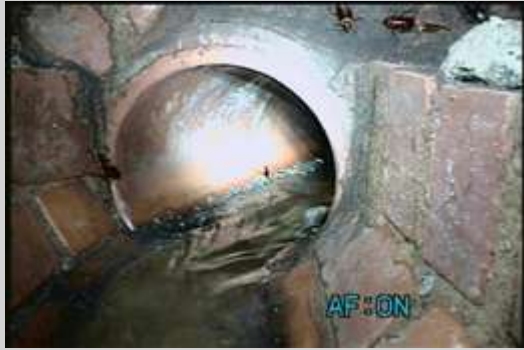
9 O'Clock Inflow

8 in. Circular Gravity Sewer
Pipe In @ 9 O'Clock

Invert Depth: **14.90** (ft.) Flow Characteristics: **Fast**

Infiltration: **None**
